Effect Of Interfiber Spacing On
The High Temperature Deformation
Of Al-Al₃Ni Composites

by Harry Colson Lewis

Submitted in Partial Fulfillment of the
Requirements for the Degree of
Naval Engineer and the Degree of
Master of Science in Mechanical Engineering
at the

MASSACHUSETTS INSTITUTE OF TECHNOLOGY

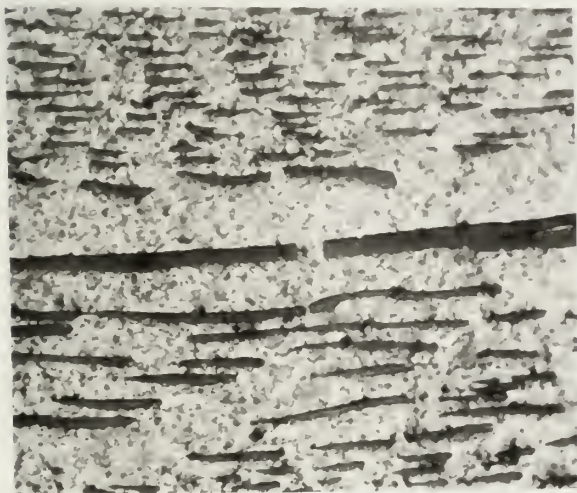
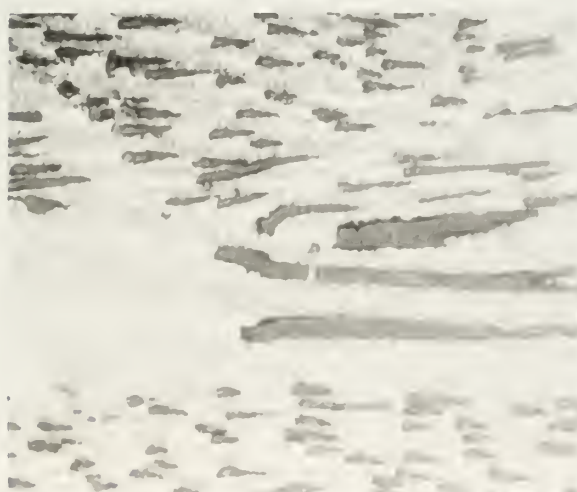
Figure I.b. Fiber depleted grain boundaries, longitudinal view, with fractured fibers. 900 x

Figure I.c. Fiber depleted grain boundary, longitudinal view, with fractured fibers, missing sections removed in polishing. 900 x

The first group of 250°C test specimens examined were numbers 1/17, 3/25, and 3/26, which were grown at 3.4 cm/hr. Number 1/17 failed with a jagged cross-sectional break (see Appendix A., Figure XIII) and exhibited good strength. Three grains were counted in the cross section; however, the fibers were well aligned on both sides of the grain boundaries. This was the only specimen in which broken fibers within the grains (not at grain boundaries) were in evidence (see Figure XI). Sample number 3/25, which failed with a cross section (cone) break, had the highest strength of the three. There were no grain boundaries in its cross section, and the alignment of the fibers longitudinally was excellent. Specimen number 3/26 had two grains in its cross section, and it failed in jagged matrix shear. Figure XII demonstrates the multiple shear planes of the jagged shear failure. The entire left portion shown in the figure has sheared in a plane parallel to the actual failure plane. The fibers can be seen to have been bent in the lower right hand corner, in order to align themselves parallel to the shear plane. The overall alignment was excellent on both sides of the grain boundaries. Although there were no broken fibers within the grains, the coarse fibers in the grain boundaries had fractured (see Figure I.b and c.).

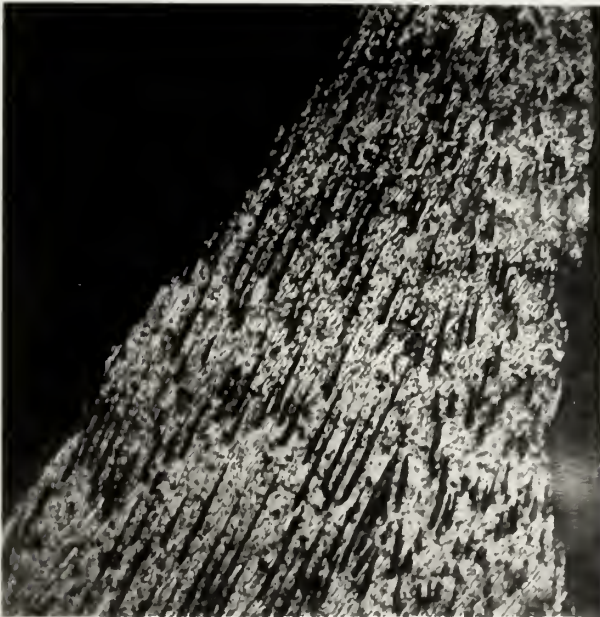
Figure II.a. Banded areas
of misaligned fibers, no
grain boundaries. 200 x

Figure II.b. Banded areas
of misaligned fibers, no
grain boundaries. 600 x

The directional solidification of 6.13 and 6.2 wt % Ni composites resulted in complete parallel alignment of the fibers at only the 5.2 cm/hr growth rate. The other growth rates resulted in microstructural defects as shown in Figures I and II. The first of the two types of defects noted was fiber depleted grain boundaries (Figure I.a., b, and c.) with the fibers having varying degrees of misalignment with respect to the growth direction. The second defect was a misalignment of groups of fibers with respect to each other resulting in a banded effect (Figure II.a., and b.).

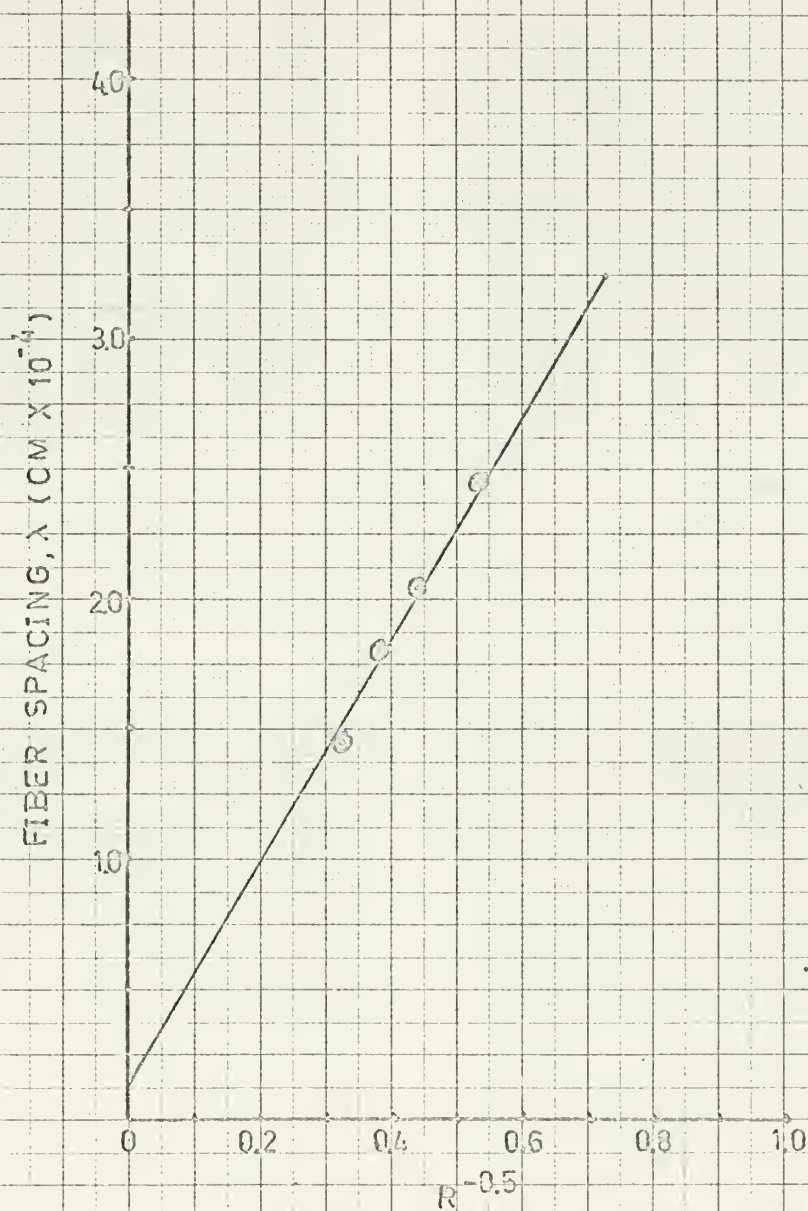
FIGURE IX - FIBER SPACING, λ , vs
GROWTH RATE, $R^{-0.5}$

The results of the fiber count and interfiber spacing measurements are given in Figure IX. The slope of the interfiber spacing, (microns), versus the inverse square root of the growth rate, $R^{-\frac{1}{2}}$ (cm/hr) $^{-\frac{1}{2}}$, was determined to be $4.25 \times 10^{-4} \text{ cm}^{3/2} \text{ hr}^{-\frac{1}{2}}$. Photographs of the microstructures of the four growth rates are shown in Figure X.a., b., c., and d.

The measurement of fiber spacing for each growth rate was made by linear and area counts. The results shown in Figure IX are in good agreement with those of Hertzberg, Lemkey, and Ford.⁷ As the solidification speed increased the eutectic Al_3Ni prefers the low surface energy rod formation. The fiber diameter and interfiber spacing becomes progressively finer as growth rate increases. Along the grain boundaries, however, considerable coarsening of structure takes place. In Figure I.a., b., and c., these coarse fibers can be seen in both the cross-sectional and longitudinal views. In Appendix A, the tabulation data includes the number of grains that were counted in the cross section of those specimens that were microscopically examined. The general trend of the observations is that the number of grains in the cross section tends to increase with increasing solidification rate. As will be discussed later it is believed that transient disturbances in the solidification process do not damp out at the higher growth rates.

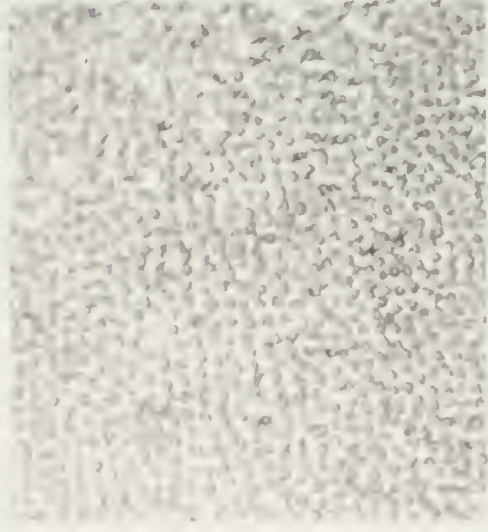
Figure X.a. 3.5 cm/hr growth
rate, interfiber spacing.
1600 x

Figure X.b. 5.2 cm/hr growth
rate, interfiber spacing.
1600 x

Figure X.c. 6.9 cm/hr growth
rate, interfiber spacing.
1600 x

Figure X.d. 9.4 cm/hr growth
rate, interfiber spacing.
1600 x

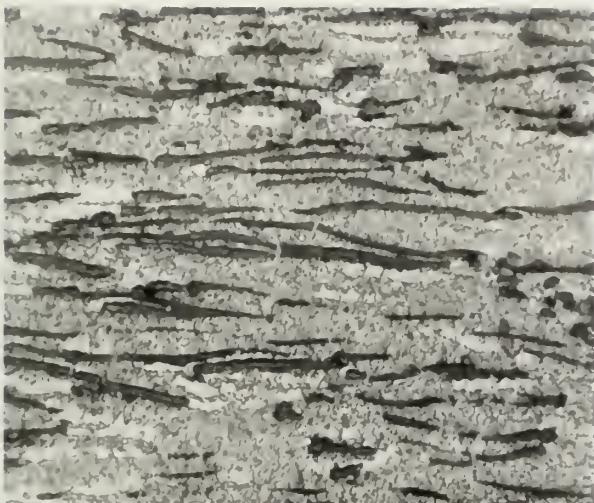
Figure XI. Fractured fibers,
not at grain boundary.
900 x
